2011 Basin Highlights Report for the Rio Grande Basin in Texas

An update on Water Quality and Basin Activities

International Boundary and Water Commission, U.S. Section,
Texas Clean Rivers Program

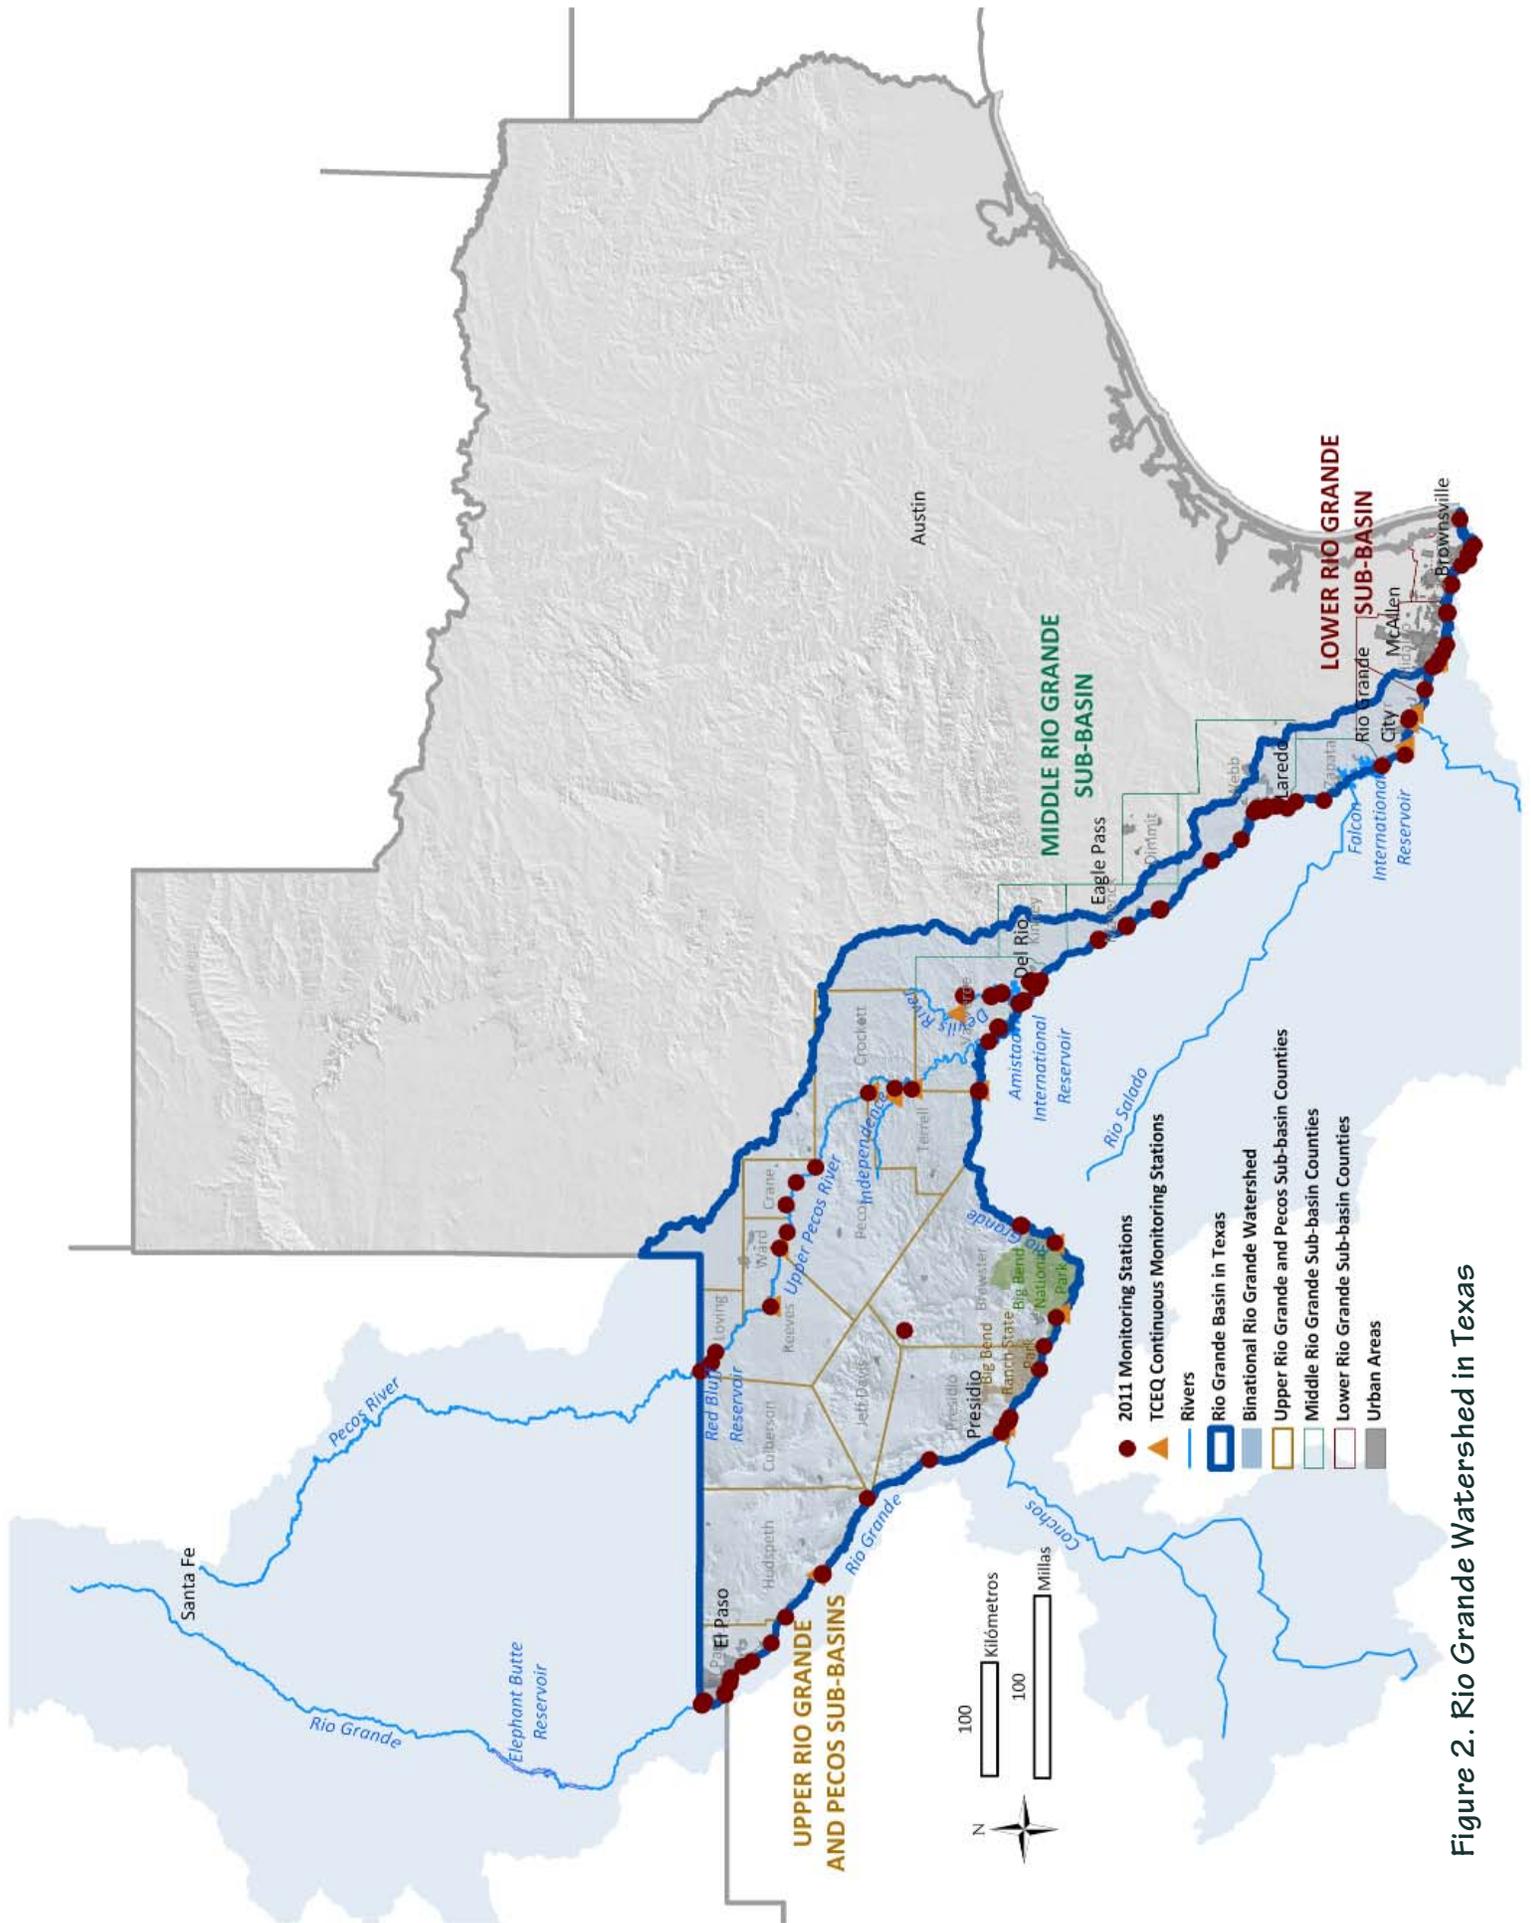
Figure 2. Rio Grande Watershed in Texas

The USIBWC CRP study area for this report is the Rio Grande Basin in Texas (Figure 2). For the purpose of coordination and planning, the USIBWC CRP study area has been divided into four sub-basins:

The Rio Grande/Rio Bravo watershed covers an area of approximately 924,300 square kilometers (335,000 square miles). Approximately half of the watershed is in the United States and the other half in Mexico (Figure 1). Roughly 50,000 square miles of the watershed are within Texas (Figure 2).

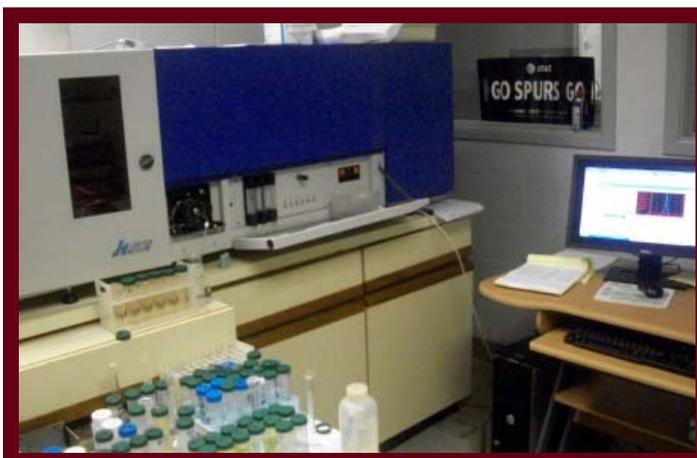
A mass spectrometer used to analyze metals and inorganic compounds at Alamo Analytical Laboratories

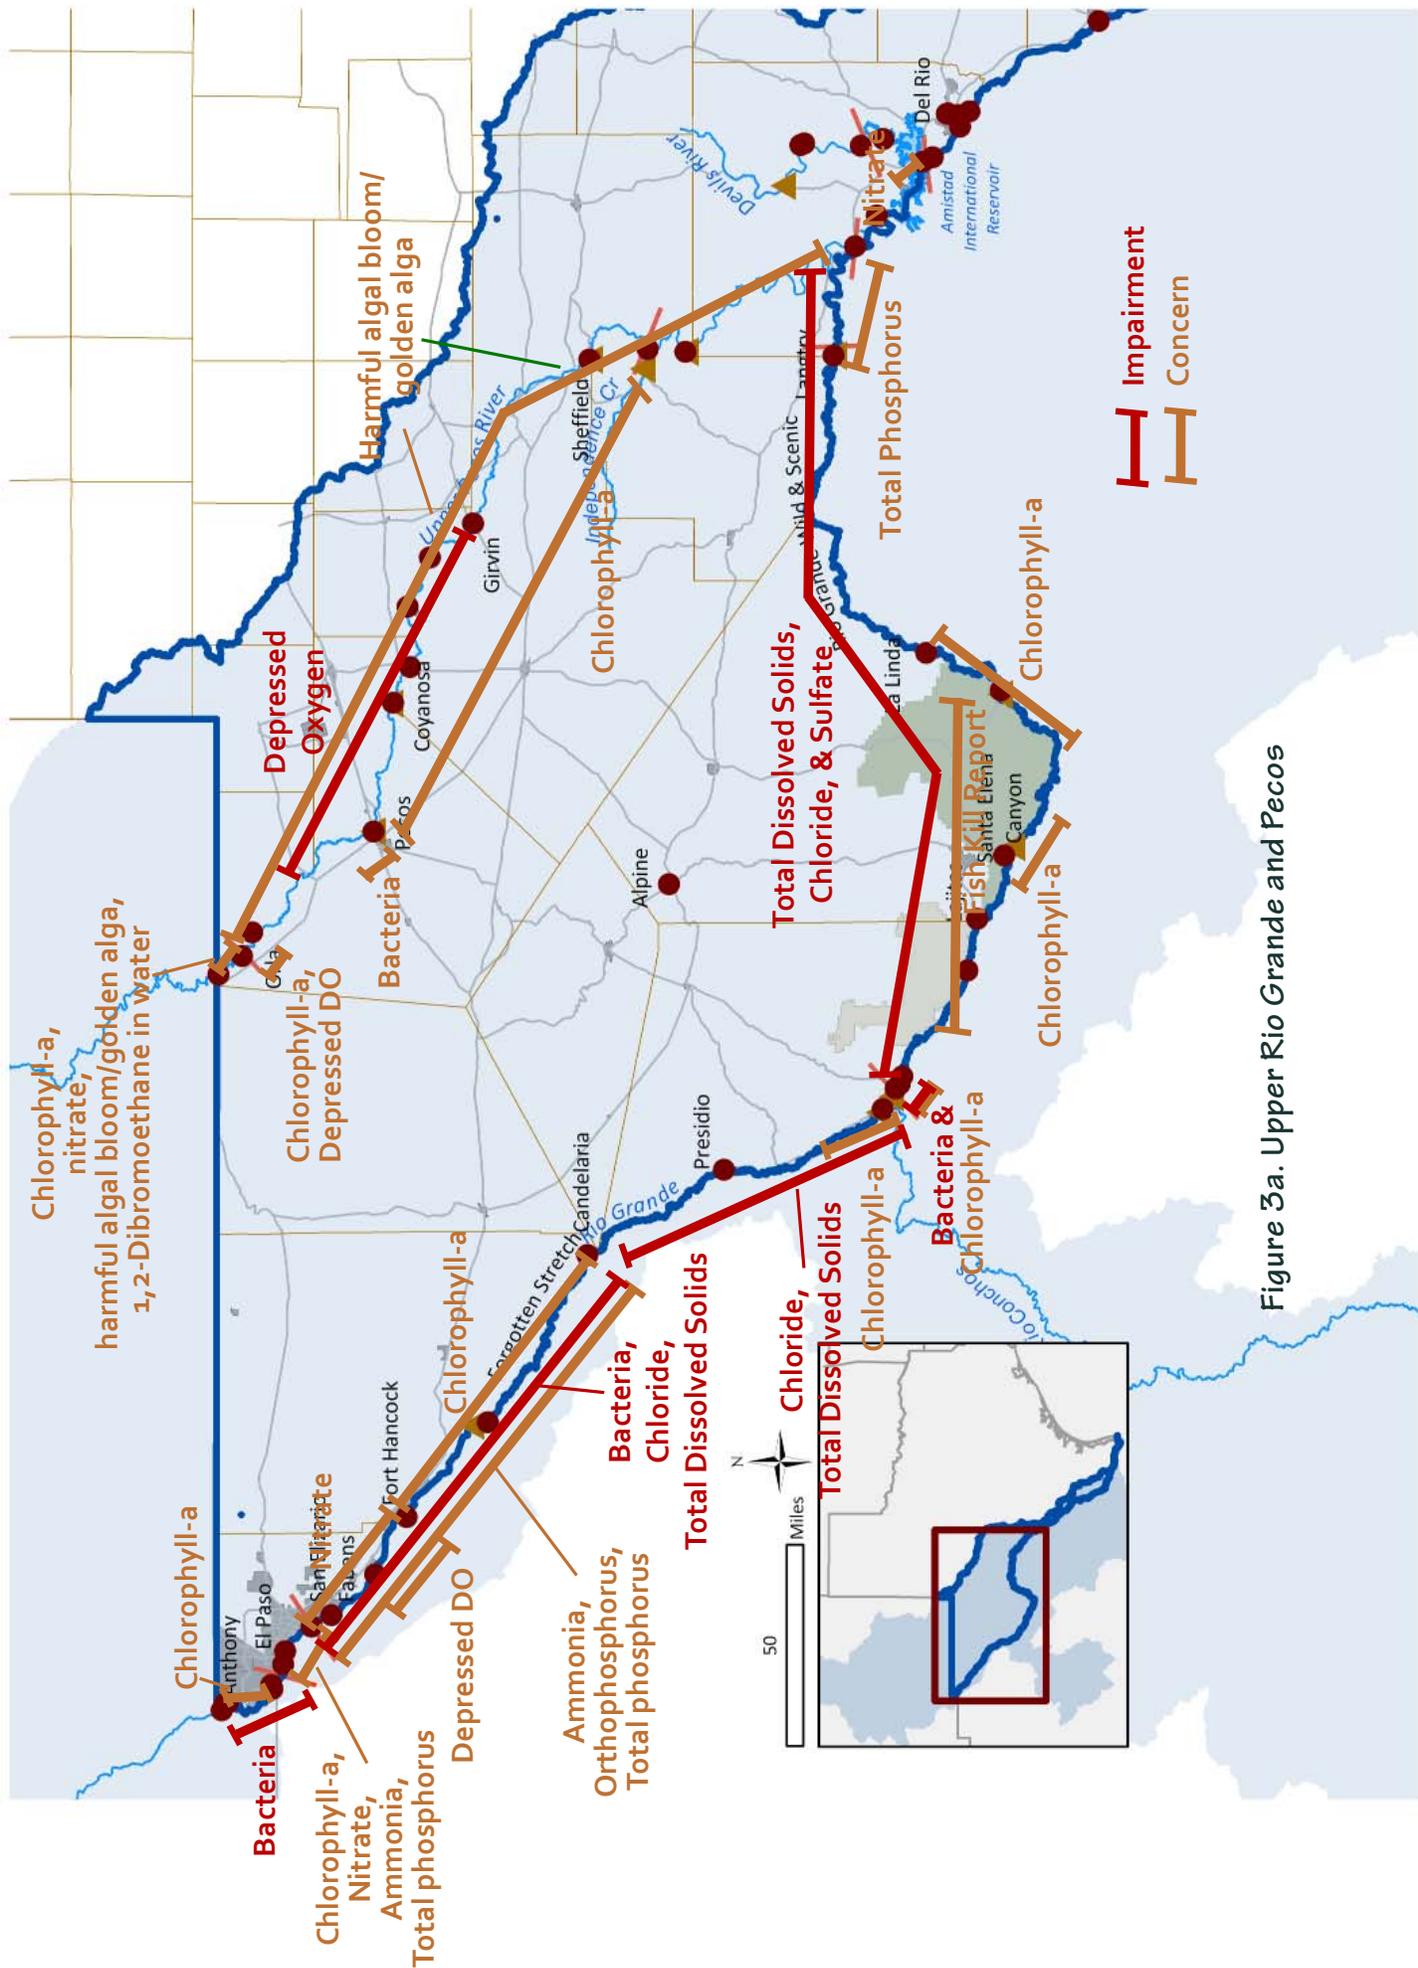
Figure 3a. Upper Rio Grande and Pecos

Figure 3a. Water Quality Impairments and Concerns in the Rio Grande Basin

Major water quality issues throughout the basin include bacteria and salinity. **Impairments and concerns in the Rio Grande Basin are listed in Table 5 and shown in Figure 3 (a-c).** The Draft 2010 Integrated Report lists additional segments as impaired from the 2008 Integrated Report. River water with high bacteria levels may pose health risks to swimmers and other recreational users. High salinity can damage crops, is expensive to treat for drinking, and is harmful to freshwater fish and aquatic invertebrates. USIBWC CRP is committed to collecting the necessary water quality information so that the appropriate authorities can make decisions pertaining to water quality issues.

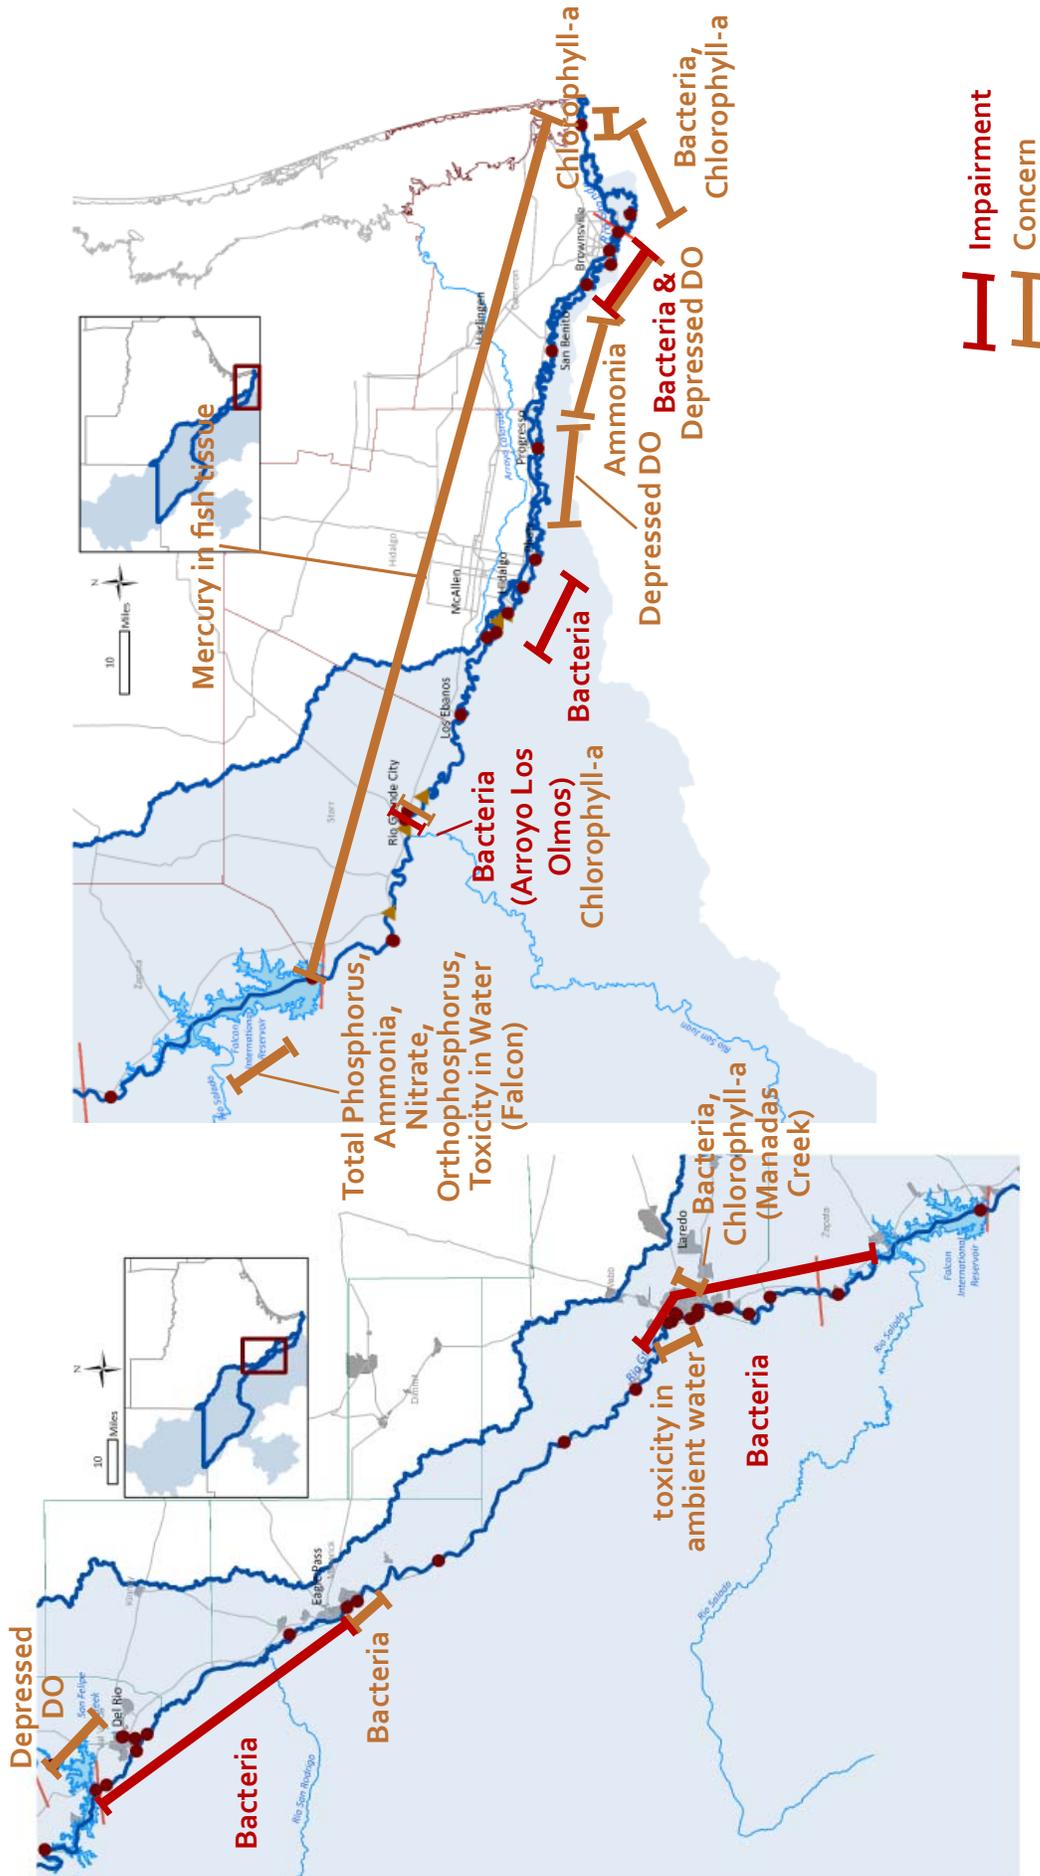
Figure 3c. Lower Rio Grande

Figures 3b and 3c. Water Quality Impairments and Concerns in the Rio Grande Basin

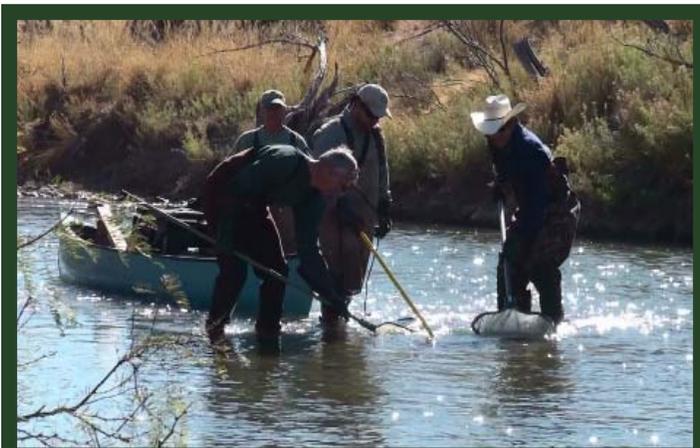
Field crews collect fish via electroshocking method at Station 13249 near Sheffield, December 2010

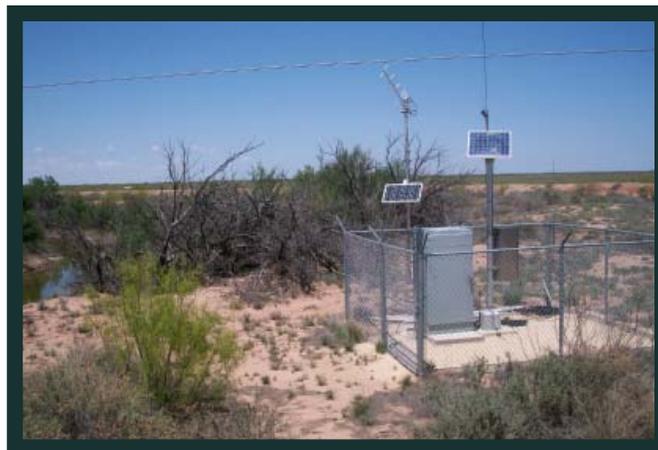
The continuous water quality monitoring station on the Pecos at Pecos, TX, April 2010

The TCEQ currently operates six CWQM stations on the Pecos River and will soon be expanding its network to eight. The data generated is being used to monitor changes in salt concentrations (using specific conductance) and surface water flow associated with salt cedar removal, to collect data to support research on the cause of toxic golden alga blooms, to provide data for the Integrated Report, and to support the Pecos River WPP by monitoring dissolved oxygen. The two new sites will be installed at Girvin, TX and Red Bluff, NM in support of the WPP.

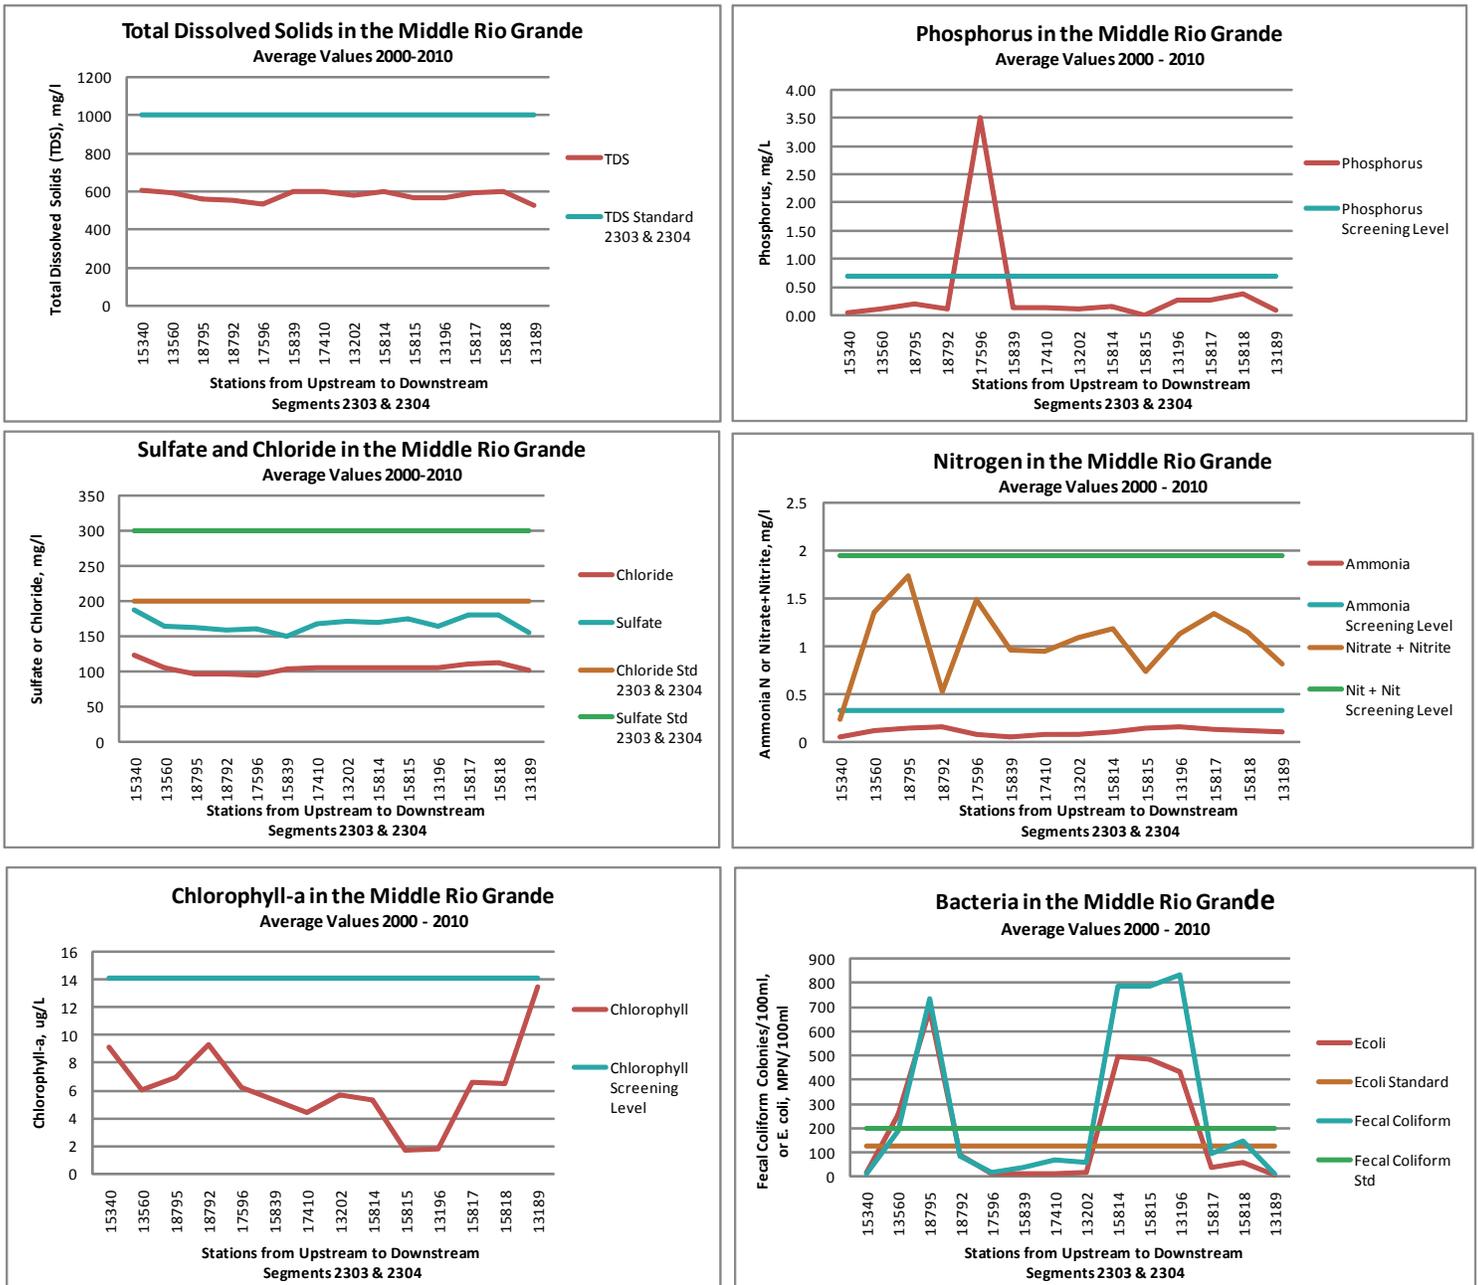
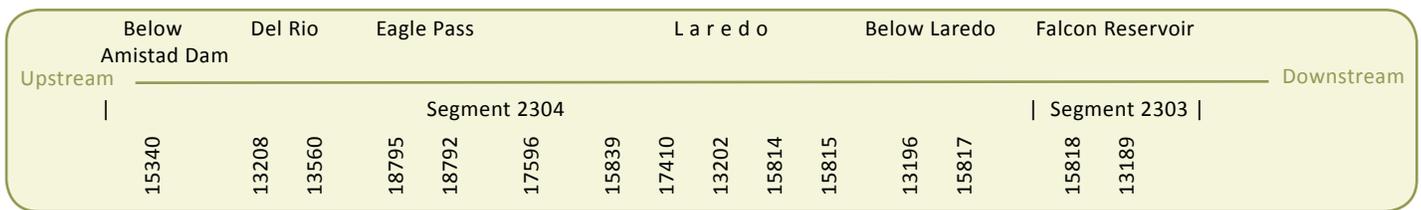
Figure 9. Graphs of major water quality parameters in the Middle Rio Grande

The graphs above show 11-year averages of TDS, sulfate, chloride, phosphorus, ammonia nitrogen, nitrate + nitrite, chlorophyll-a, and fecal coliform and *E. coli* bacteria for 14 stations in the Middle Rio Grande, with the upstream-most stations on the left and downstream stations on the right. Standards or secondary screening level criteria show where certain parameters are high. Bacteria is the principal problem in the Middle Rio Grande, particularly in the Del Rio and Laredo areas.
